Cumberland River Basin  
Remedial Construction  
Wolf Creek Dam, Kentucky

# Wolf Creek Dam Concrete Diaphragm Walls Final Completion Reports Phases I and II

December 1988

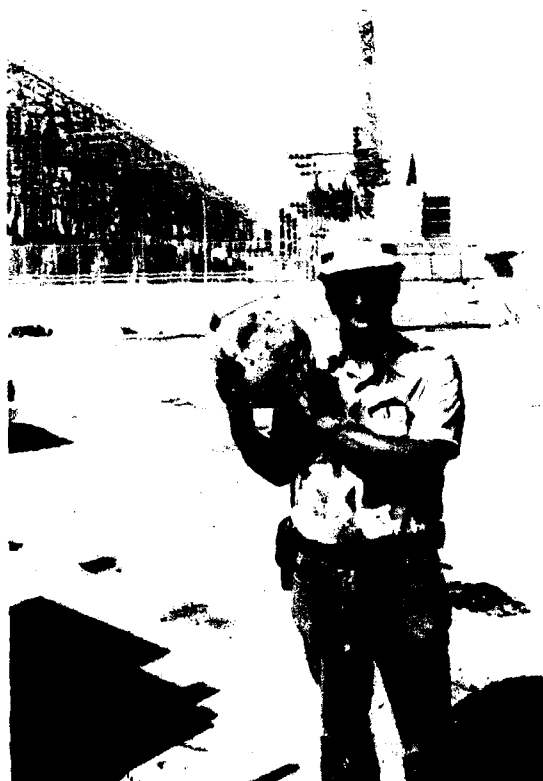
60. Wooden sphere replaced basketball as retrievable travelling plug.
